FIELD TEST WALL TECHNOLOGIES

SUPA PANEL

SHAFT WALL SYSTEM 1A – WIDTH 93 mm

WALL SYSTEM TESTING

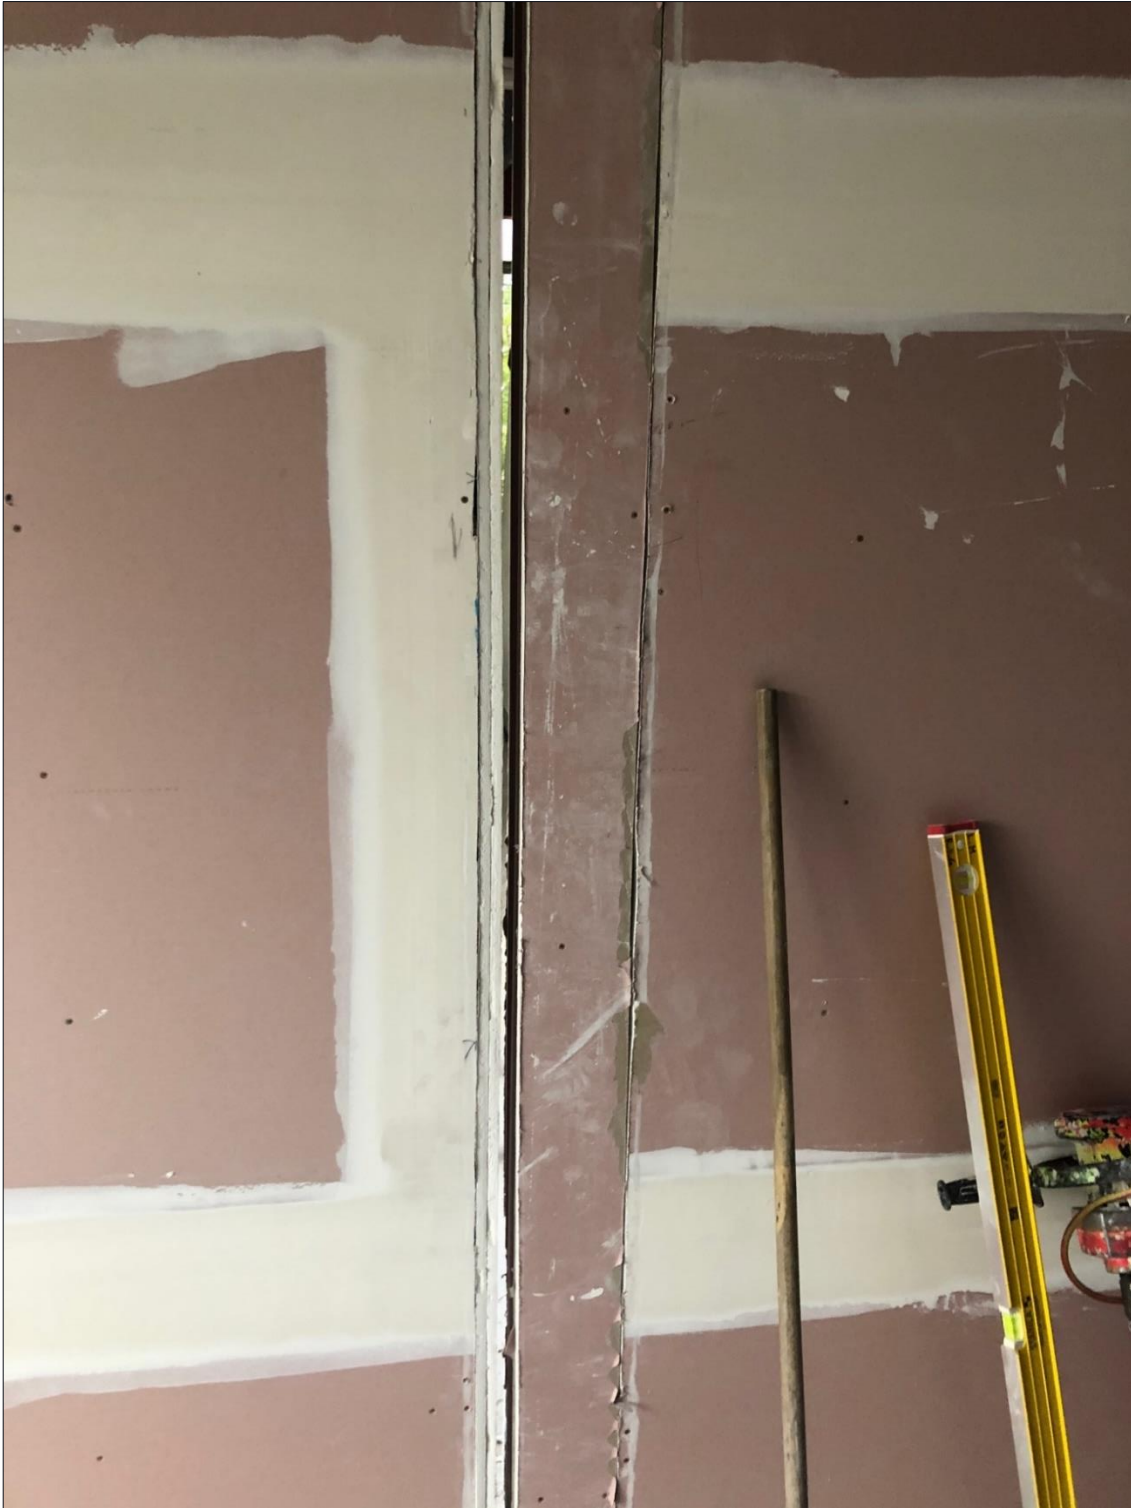
Figure 2: Structural break in bounding wall

The test sample is to be mounted at a dedicated location to divide space into two separate rooms. The sample location includes a structural break to limit sound flanking via the bounding walls. The structural break is shown in Figure 2. The break has subsequently been packed with rubber.

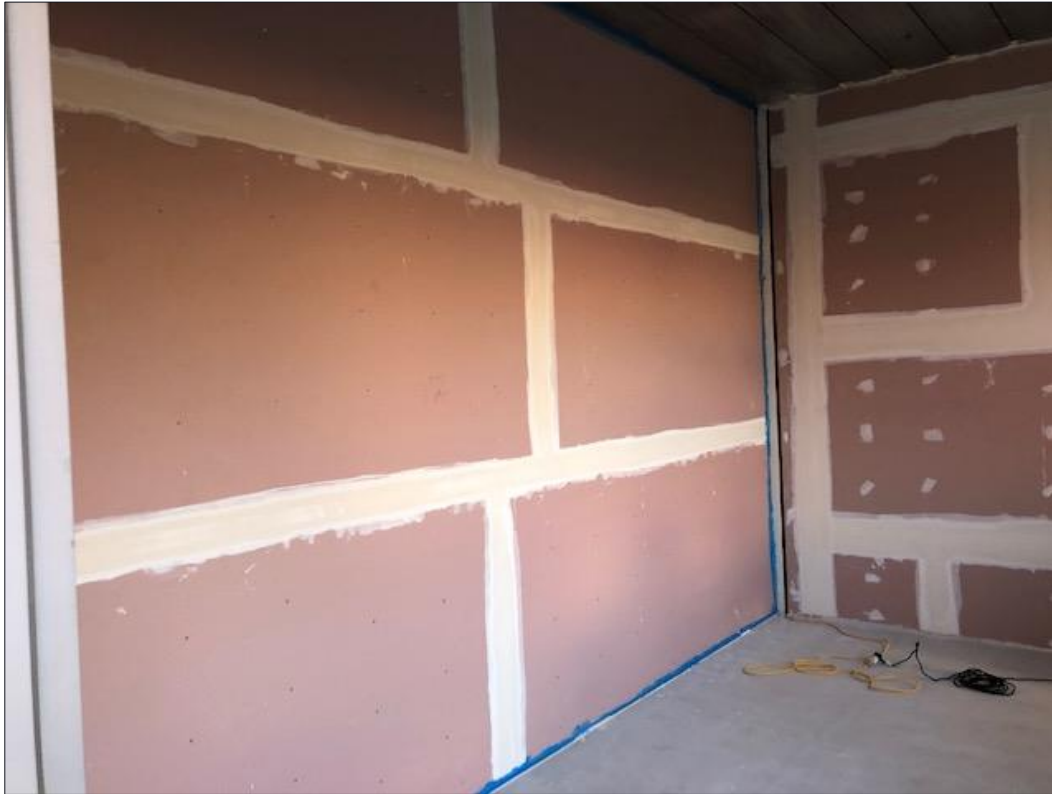
Figure 4: Wall panel system test sample

- 64 mm thick panel (380 kg/m³ density ; 0.35 mm thick steel skins)
- 16 mm steel batten (no cavity insulation)
- 13 mm Knauf Fireshield (800 kg/m³ density)

The panel can be described as a steel encased, aerated concrete panel system with a proprietary joint detail. The wall panel was mounted within steel tracks top and bottom and abutted the bounding walls on one side of the structural break only.

The wall panel had been installed in accordance with a typical installation detail for a riser shaft, i.e. all caulking and sealing was completed from one side only, in this case the source room side. The lining on battens was mounted on the source room side of the wall.

The installation of the wall panel system is shown in Figure 4.

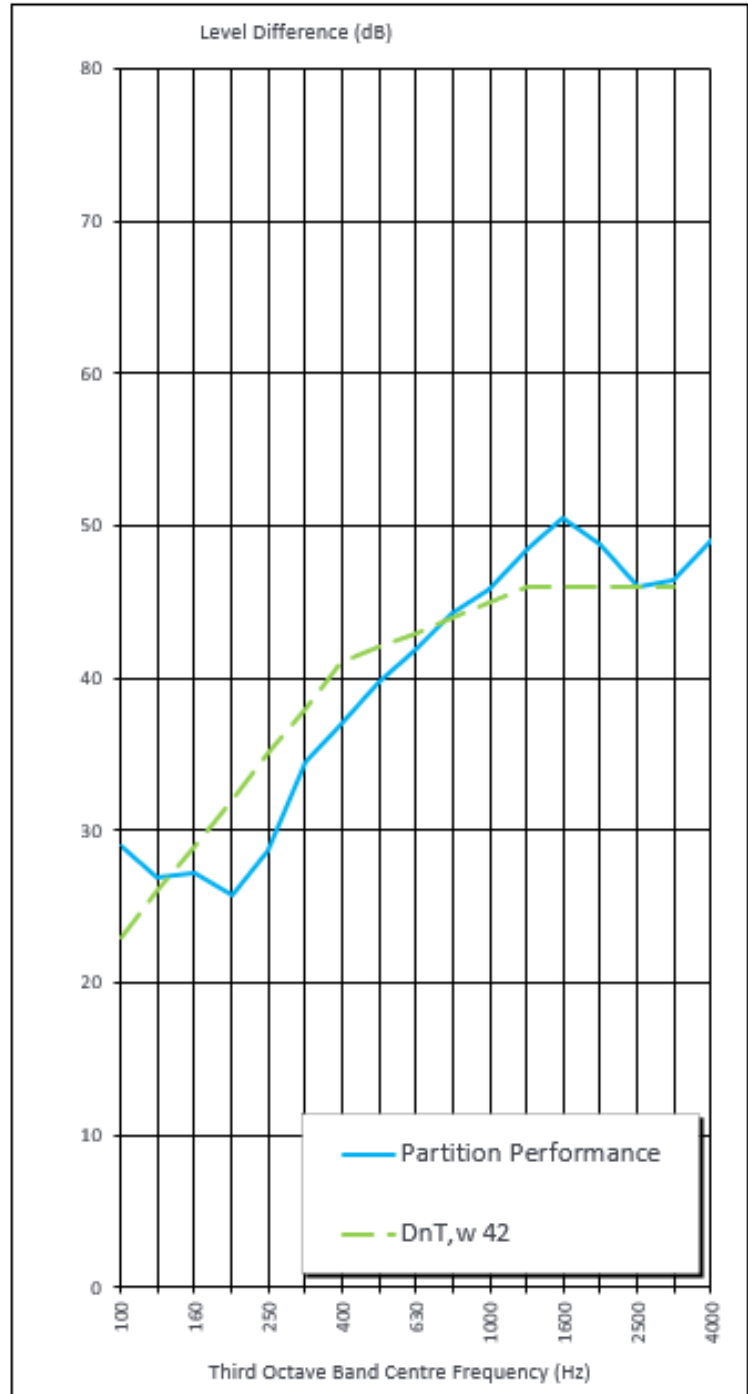
Figure 5: Sound Insulation Test Results:

The sample was tested on 20 March 2020. The test result is provided in Figure 5.

System: SHAFT WALL SYSTEM 1A - 64mm wall + 16mm batten + 13mm Knauf Fireshield + no insulation

Frequency (Hz)	DnT* (dB)	Adverse Deviation (dB)	Receiving RT (s)
50			
63			
80			
100	29.0		0.8
125	26.9		0.7
160	27.2	1.8	0.7
200	25.7	6.3	0.5
250	28.7	6.3	0.6
315	34.5	3.5	0.6
400	37.0	4.0	0.5
500	39.8	2.2	0.4
630	41.9	1.1	0.4
800	44.3		0.4
1000	45.8		0.4
1250	48.5		0.4
1600	50.5		0.5
2000	48.8		0.5
2500	46.0		0.4
3150	46.5		0.4
4000	49.0	-	0.4
Sum of Adverse Deviations			25.2

DnT,w	42
C ₁₀₀₋₃₁₅₀	-2
C _{tr,100-3150}	-5
